**PRELIMINARY ASSESSMENT/
VISUAL SITE INSPECTION**

**NATIONAL METALCRAFTERS
ROCKFORD, ILLINOIS**

ILD 047 032 750

FINAL REPORT

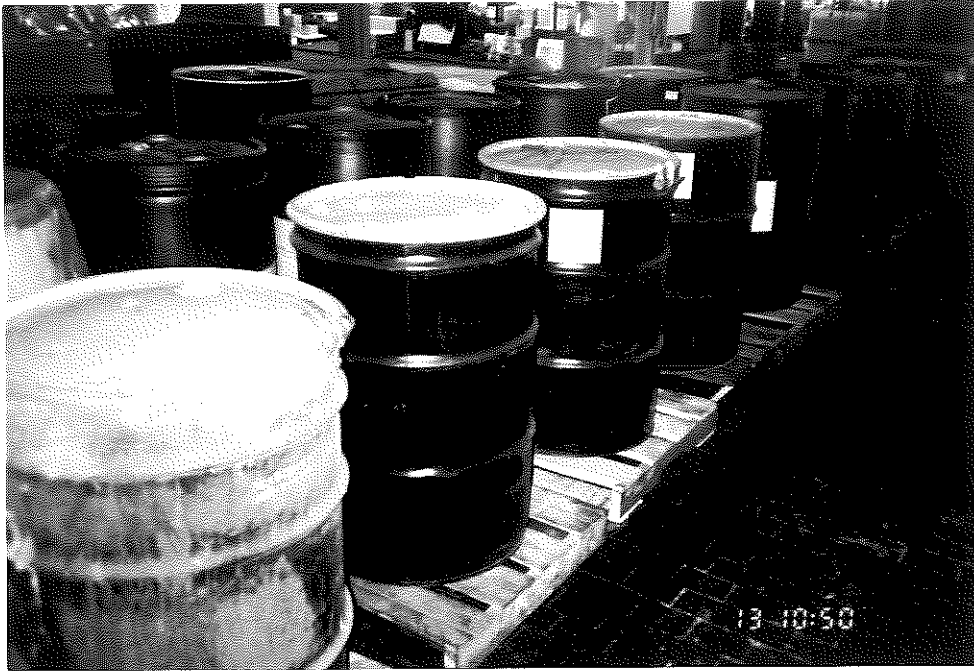
Photograph No.: 1

Observations: All the drums appear sound and no evidence of a release was observed. At the time of the VSI, RAI observed 3 drums of spent TCE and 8 drums of nickel cake (see photo 1).

Description: Hazardous Waste Storage Area. This area contains product TCE, spent TCE, and waste nickel cake.

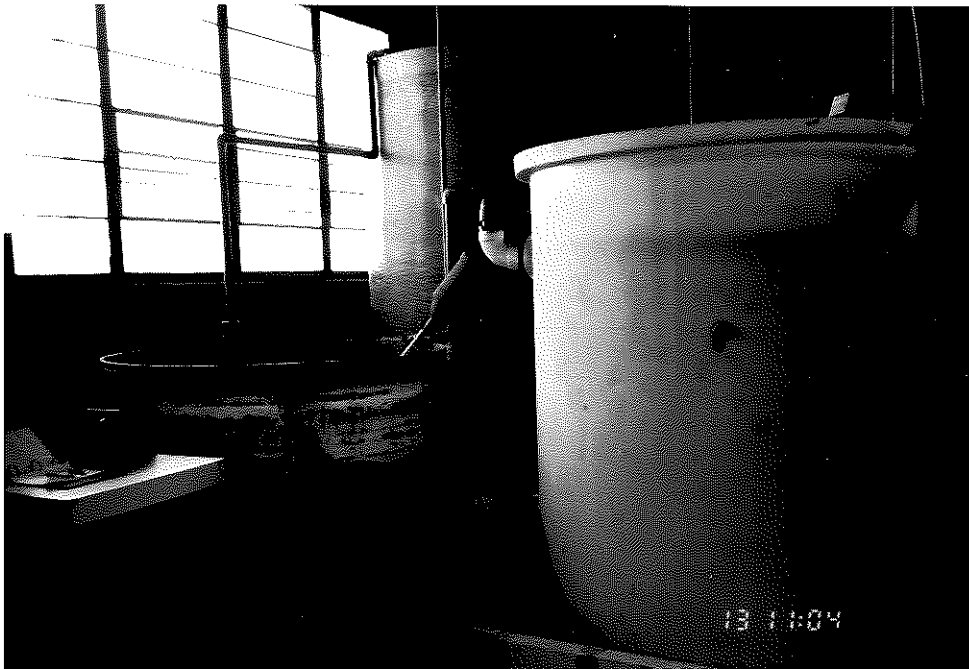
Photograph No.: 2

Observations: The unit appeared sound and no evidence of a release was observed (see photos 2 & 3).

Description: Upper Wastewater Treatment Unit. The tank in the left foreground is the waste sulfuric acid holding tank.

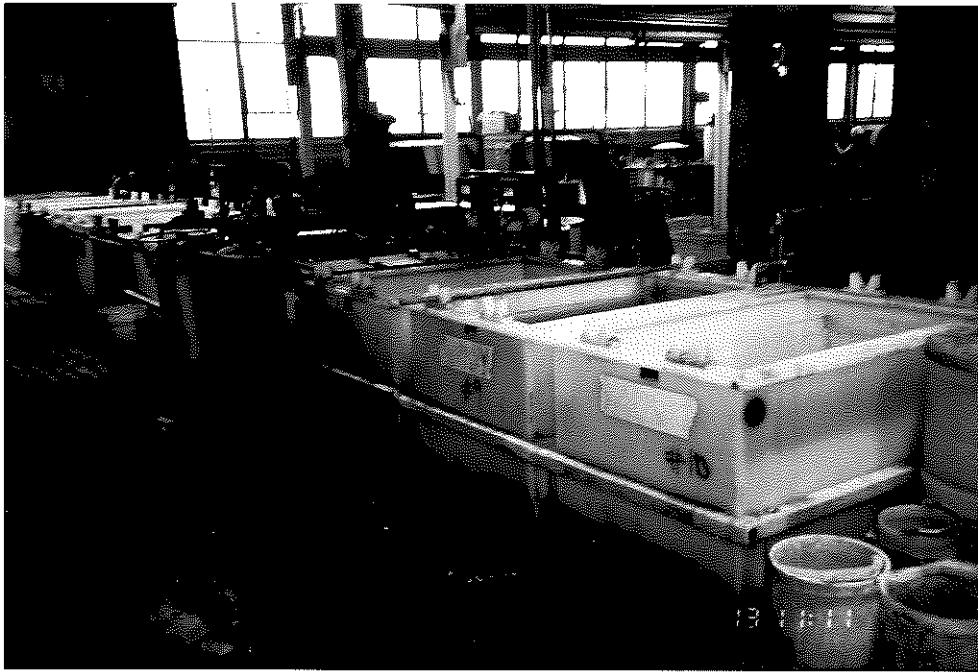
Photograph No.: 5

Description: Nickel plating line. The copper bright dip line is perpendicular to this unit.

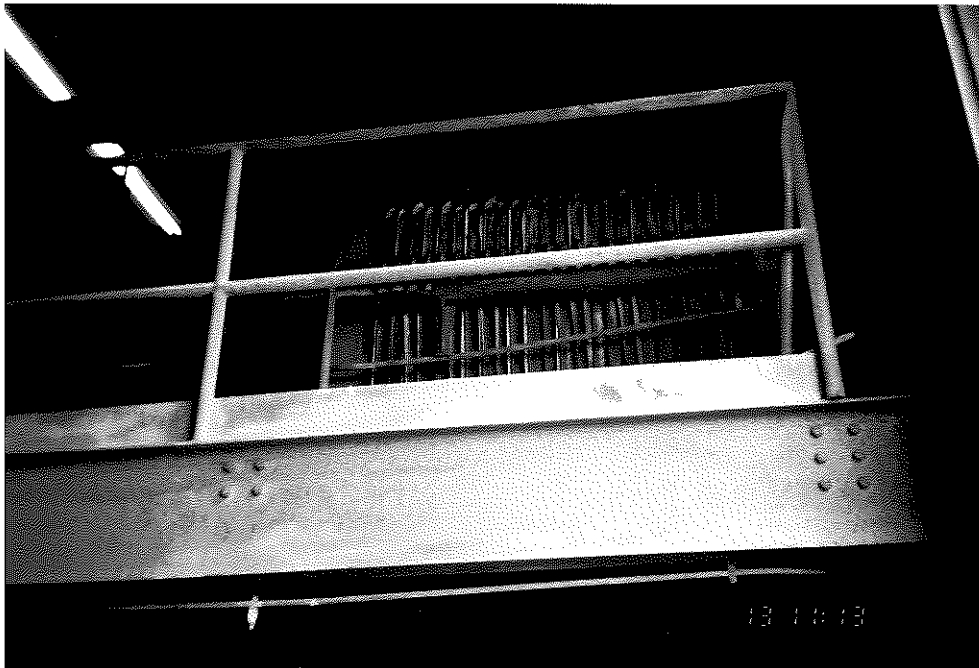
Photograph No.: 6

Observations: The unit appears sound and no evidence of release was observed (see photos 6 & 7).

Description: Zinc Plating Filter Press.

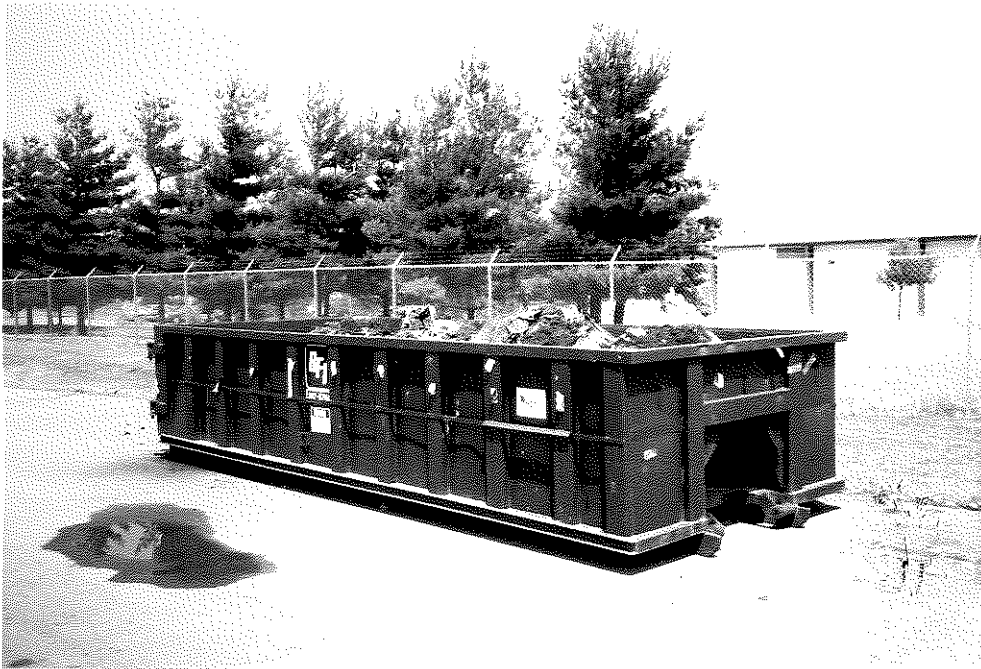
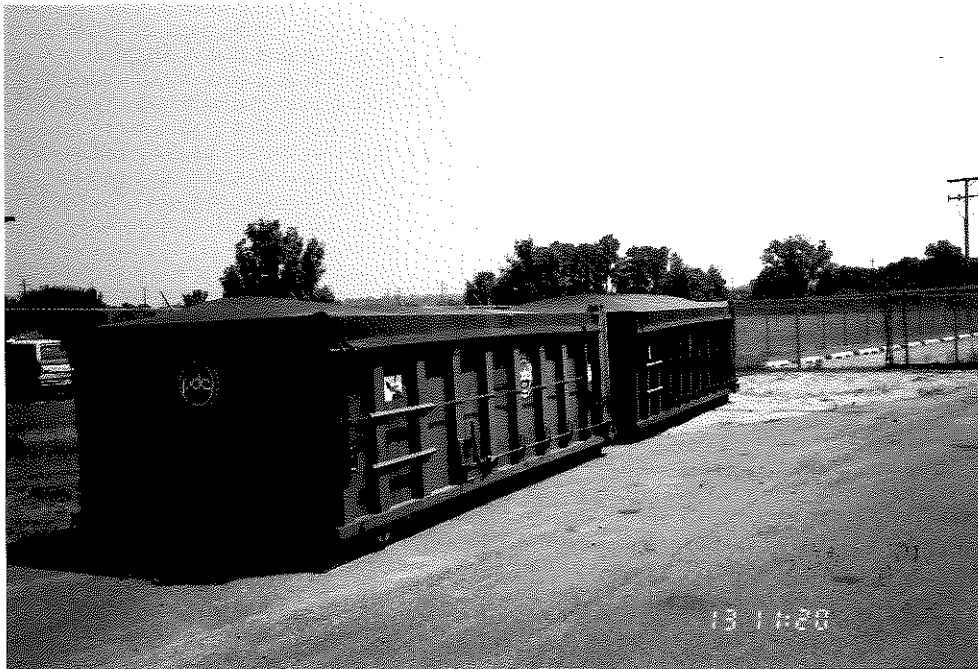
Observations: All 3 dumpsters appear sound and no evidence of release was observed (see photos 9 & 10).

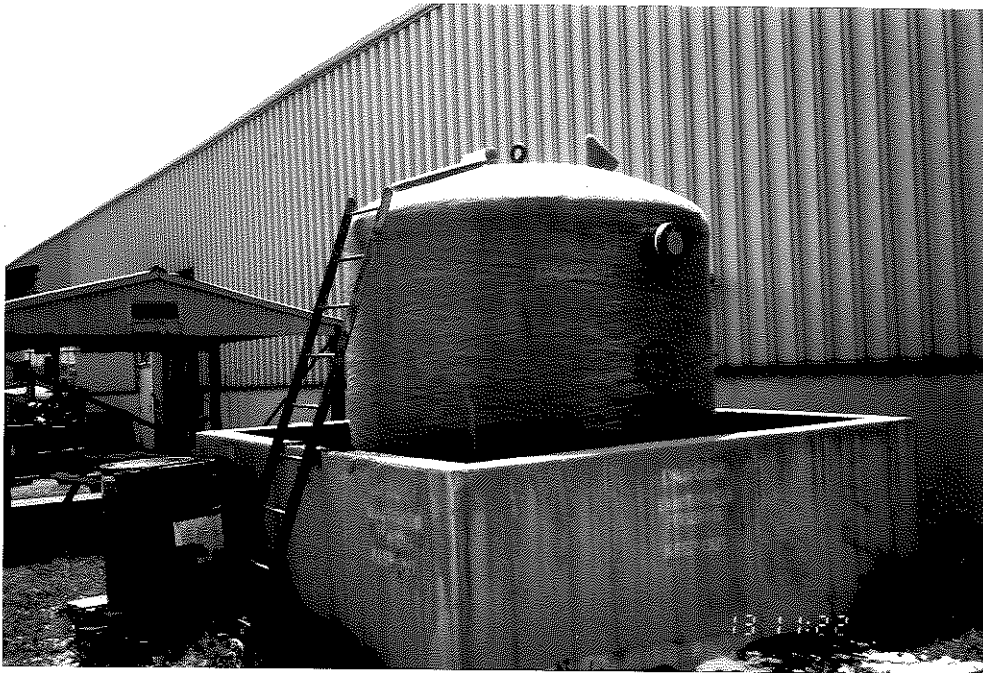
Photograph No.: 11

A release of 100 gallons of waste hydrochloric acid occurred on June 7, 1991. While pumping the waste out of the Hazardous Waste Storage Tank (SWMU 1), the spent acid spilled over the side of the tank. A pipe used to drain rain water from the secondary containment surrounding the tank had been left unplugged. When the spill occurred, the spent acid drained onto the surrounding soil. Sodium bicarbonate was spread over the spill area to neutralize the acid (see photos 11 & 12). Soil samples were taken and the results are pending.

Description: Hazardous Waste Storage Tank. The four foot high berm surrounding the tank had an unplugged drainage pipe causing a spent acid release.

<u>SWMU</u>	<u>Operational Dates</u>	<u>Evidence Of Release</u>	<u>Suggested Further Action</u>
1. Hazardous Waste Storage Tank	1958 to 1991	Spent hydrochloric acid release occurred on June 7, 1991.	Results from soil samples are pending.

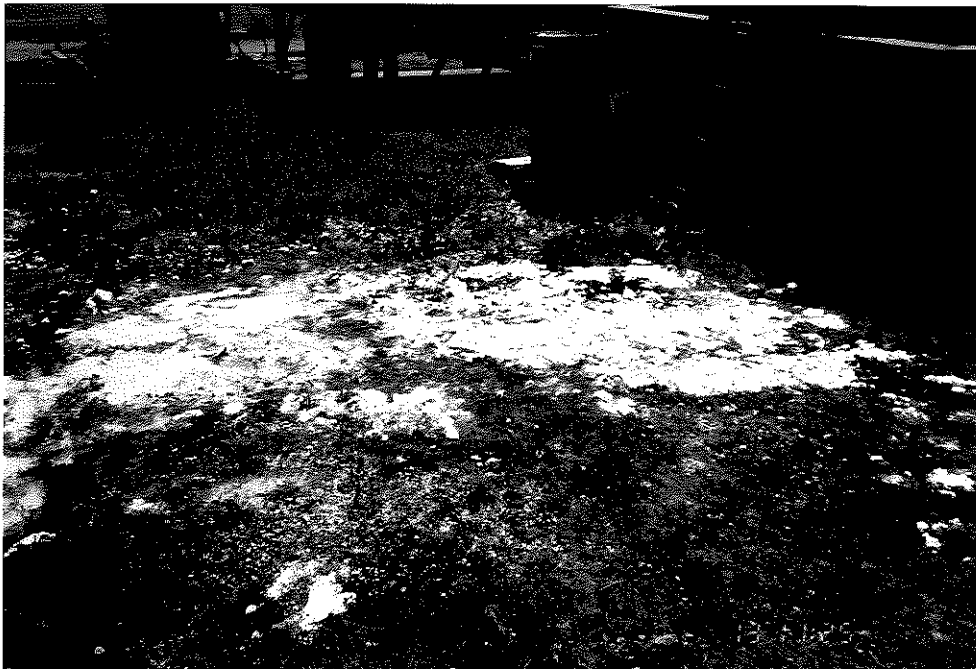
Photograph No.: 12

Description: Sodium carbonate used to neutralize June 7, 1991 spent acid release. The spent acid entered the soil via the drainage pipe at the bottom of the berm.

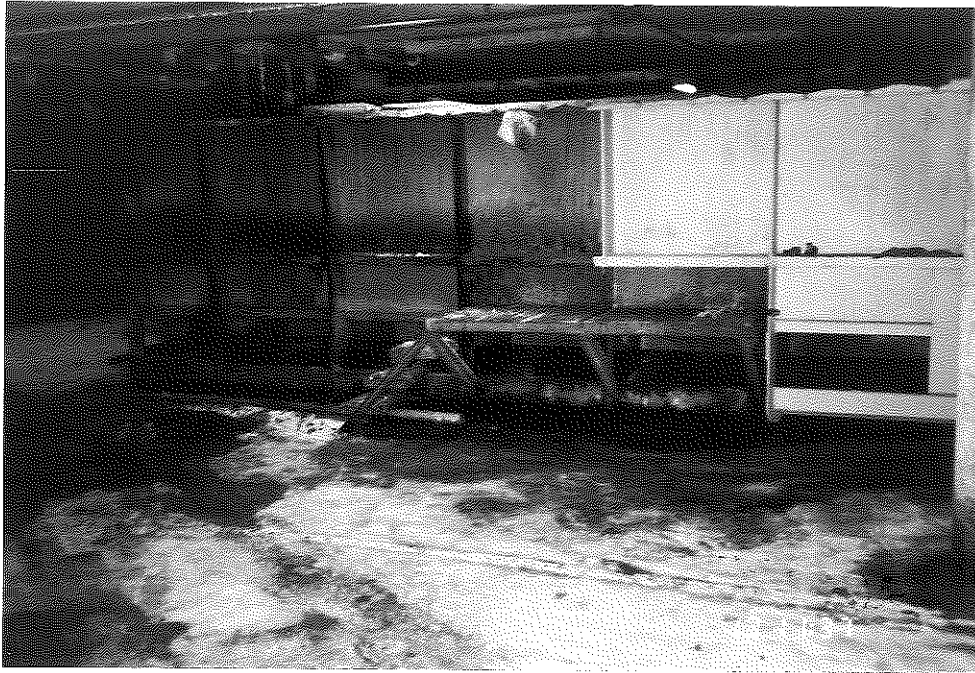
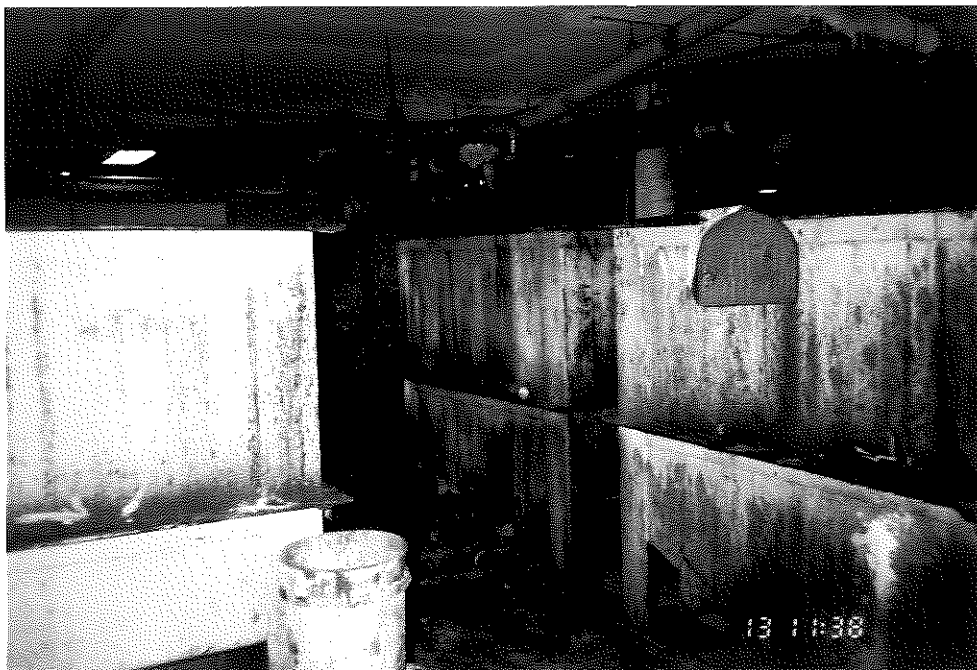
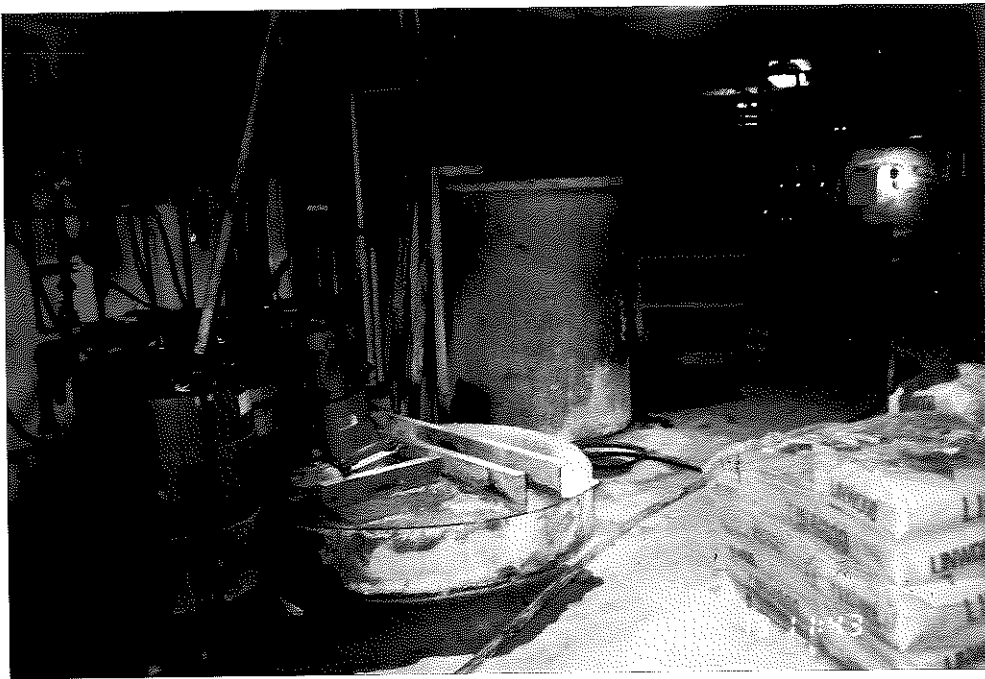
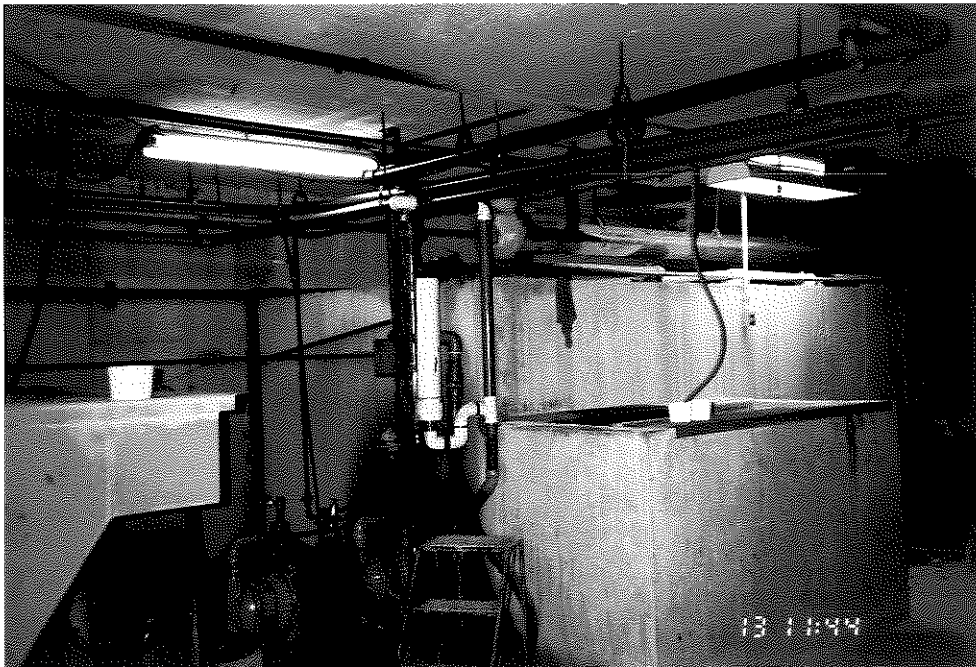
Observations: All of the visible tanks associated with this unit appeared sound and no evidence of a release was observed (see photos 13-17).

Recommendations: Since this unit is no longer in operation, no further action is recommended at this time.

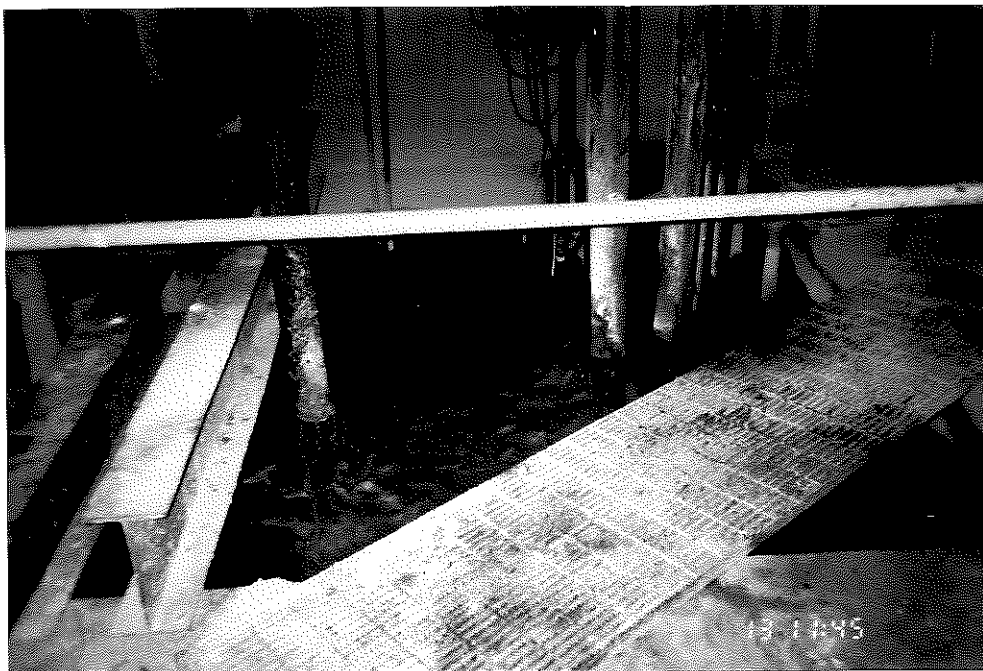
Photograph No.: 17

Description: The stabilization tank associated with the Lower Wastewater Treatment Unit.

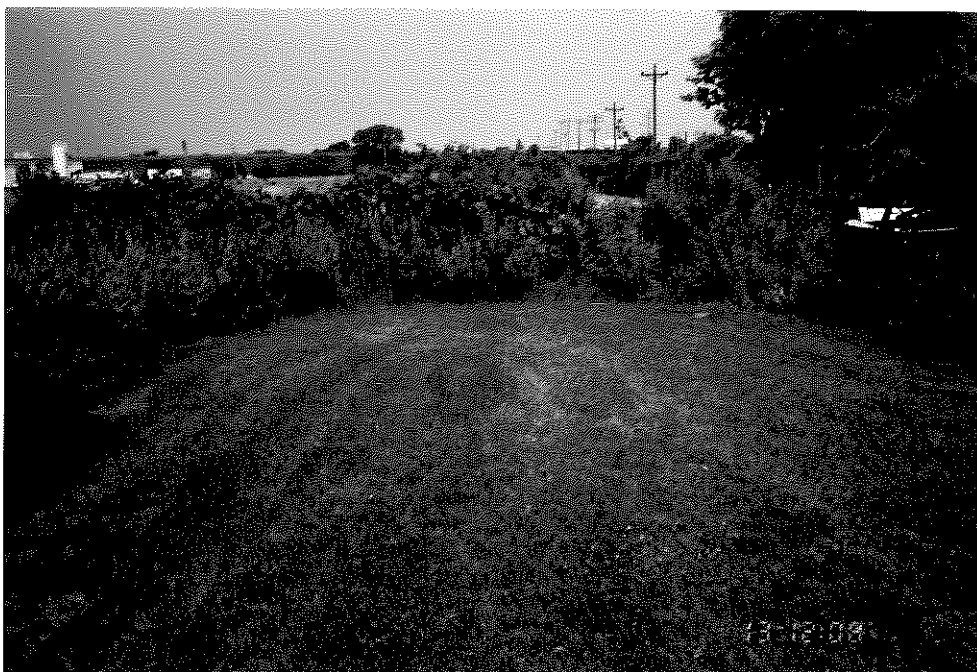
Photograph No.: 18

On April 19, 1989, 250 to 300 gallons of quenching oil was observed on the ground outside the building. Around 1974, three 500-gallon steel oil tanks were removed from the building and placed in the northeastern corner of the property. It could not be determined when the release occurred, but the oil soaked into the ground and no vegetation grew for a period of time in the 130-foot square area where the release was observed. PDC removed the spilled oil and contaminated soil and disposed of it at the Clinton Landfill in Clinton, Illinois (PDC, 1989). During the VSI, RAI observed that vegetation has been re-established in the spill area (see photo 18).

Description: Revegetated area where the April, 1989 oil spill occurred.

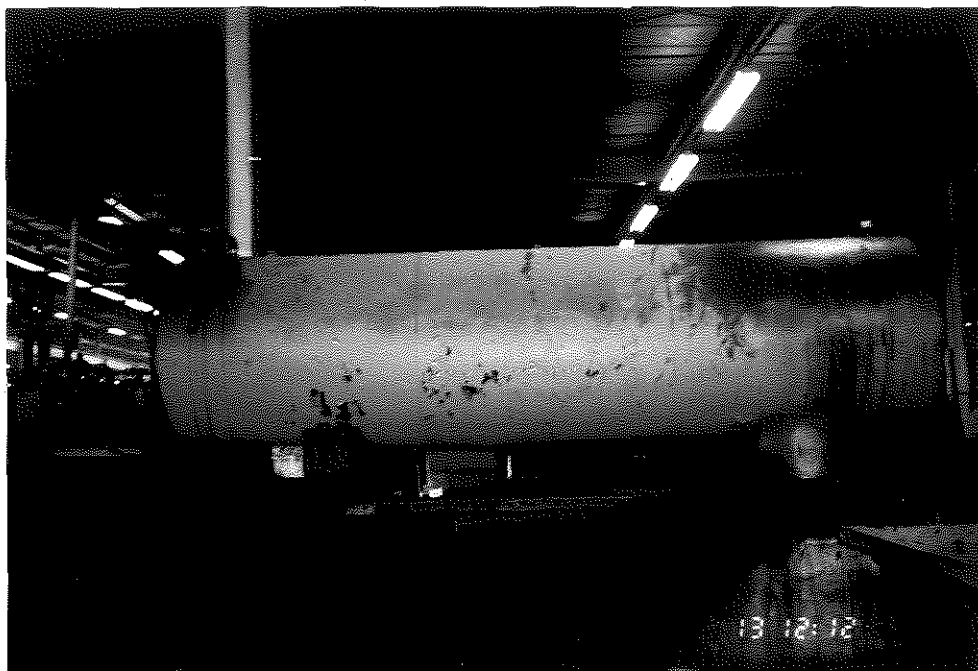
Observations: The unit appears sound and no evidence of a release was observed (see photo 19).

Photograph No.: 19
Orientation: East
Description: Waste Oil Storage Tank.

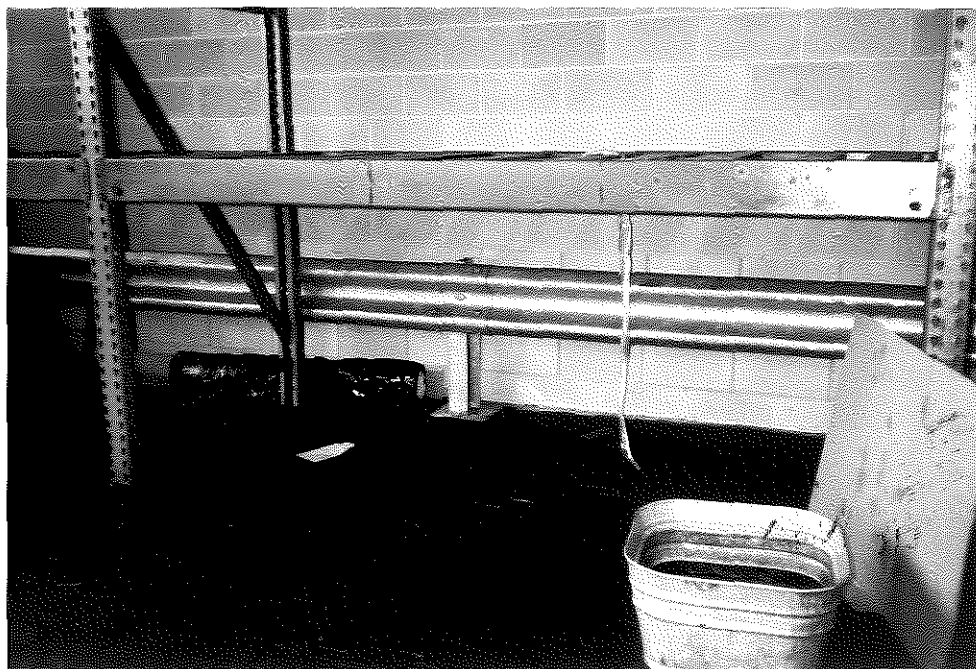
Observations: The majority of the containers did not show evidence of release but some oil was observed on the concrete floor (see photo 20).

Observations: The drums had been removed and no evidence of release was observed (see photo 20).

Photograph No.: 20
Orientation: East
Description: This area was used to store the cyanide plating waste. The container in the right foreground is a Waste Oil Satellite Accumulation Area.

Recommendations: The containers should be monitored to prevent waste oil spills.

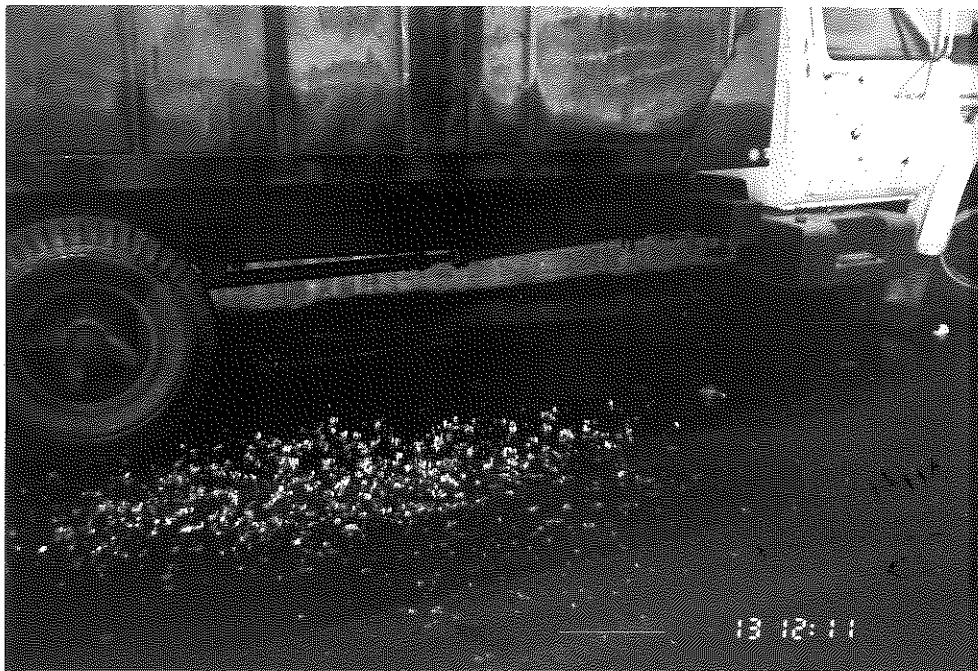
Photograph No.: 22

While viewing the bulk waste oil storage tank during the VSI, RAI observed a truck load of scrap copper with oil dripping from beneath the Scrap Copper Storage Truck (SWMU 11). The oil had pooled beneath the truck and a drain connected to the sanitary sewer was located 30 feet away. It is not known how long the release had been going on.

Release Controls: The bed of the truck is constructed of steel; however, the floor of the bed may have been breached since it is old and waste oil was observed leaking on the concrete.

Conclusions: The floor of this unit may have been breached; lubricant oil was observed dripping from it onto the ground. The concrete flooring beneath the truck is sound and any release could be contained before it had the opportunity to reach ground water, surface water, air or soil, so the potential for release to these environmental media is low. However, lubricating oil could enter the sewer system through the storm drain located 30 feet to the northeast.

Recommendations: The truck bed should be replaced with a container more suited to holding liquids. In the interim, a container should be placed beneath the truck to collect the dripping oil.
